Technical Report 627

CABLE FAILURES IN THE AN/BQS-15 SONAR SYSTEM

Analysis of failures in the depression/elevation
drive-motor power cable and recommendations
for their prevention

NAVAL OCEAN SYSTEMS CENTER
SAN DIEGO, CALIFORNIA 92152

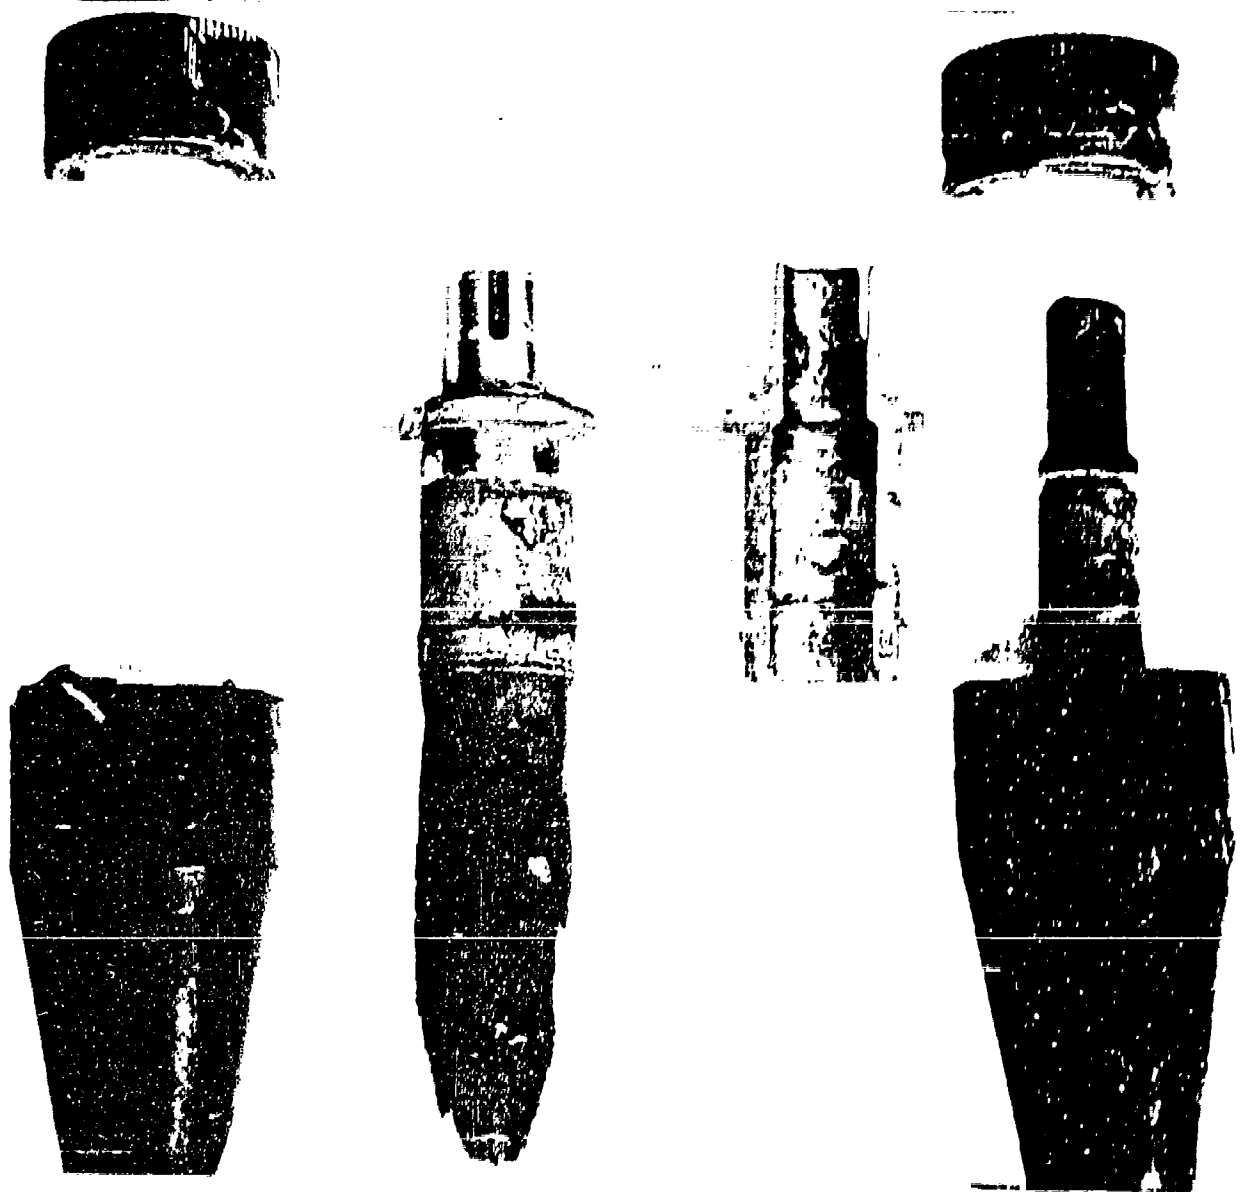
A dissection of P2 of cable W30 is shown in figure 11. This connector is the larger 90° connector shown in figure 4. Its construction is very similar to that of P1 in the previous section and the failure mode is considered to be identical. The right side of figure 11 shows a gray epoxy water block inside the stress-relief section of the mold. The water block is cracked in several places, most noticeably at the interface of the stress-relief section and the metal sleeve, near the cutout (where the wires enter the connector). At the left in this figure, lying on top of the blue insert, is a portion of the O-ring designed to prevent water from entering at the open end of the connector, rather than to keep out high-pressure water which could enter through the flooded back end (as occurred in this connector). Once water reaches the innermost section of this sleeve there is no longer any bonded area to prevent leakage.

FIGURE 11. The connector of MHC-111 and the connector.

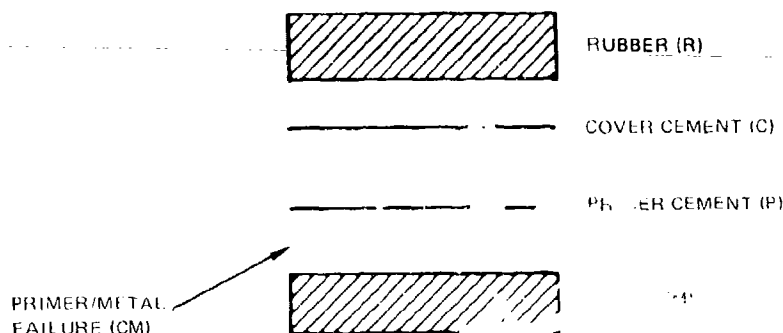
TWO COAT SYSTEM

4. The primer system used by Viking was the two coat method of bonding the elastomer to metal.

This two coat method is used when the assembly will face severe usage and extreme temperature, but the bonding temperature must be high. This is by far the best method for this application.
